School District of New Berlin  
Strategic Facilities Assessment  
Prepared by IFF  
August 2011

In the spring of 2011, the District engaged IFF to assist with this effort. During the month of May 2011, IFF visited each District facility and conducted an analysis of current building condition. Based on these assessments, IFF prepared a set of recommended short- and long-term facility improvements and completed a high-level cost estimate. Estimates represent a preliminary approximation of cost for discussion purposes. In setting priorities and recommending improvements, IFF assumed strategies that minimize costs and focus on ensuring that facilities are in compliance with current Code and life safety standards, address any deferred maintenance items, and bring facilities into standards for new construction. Standards for new construction, as used by IFF, indicates that the facility functions as it did when new and finishes are in as-new condition. Estimates do not include costs for improvements related to changing education standards or changes to meet a modern design aesthetic. IFF assumes strategies, where possible, that phase costs in over time and minimize annual outlays.

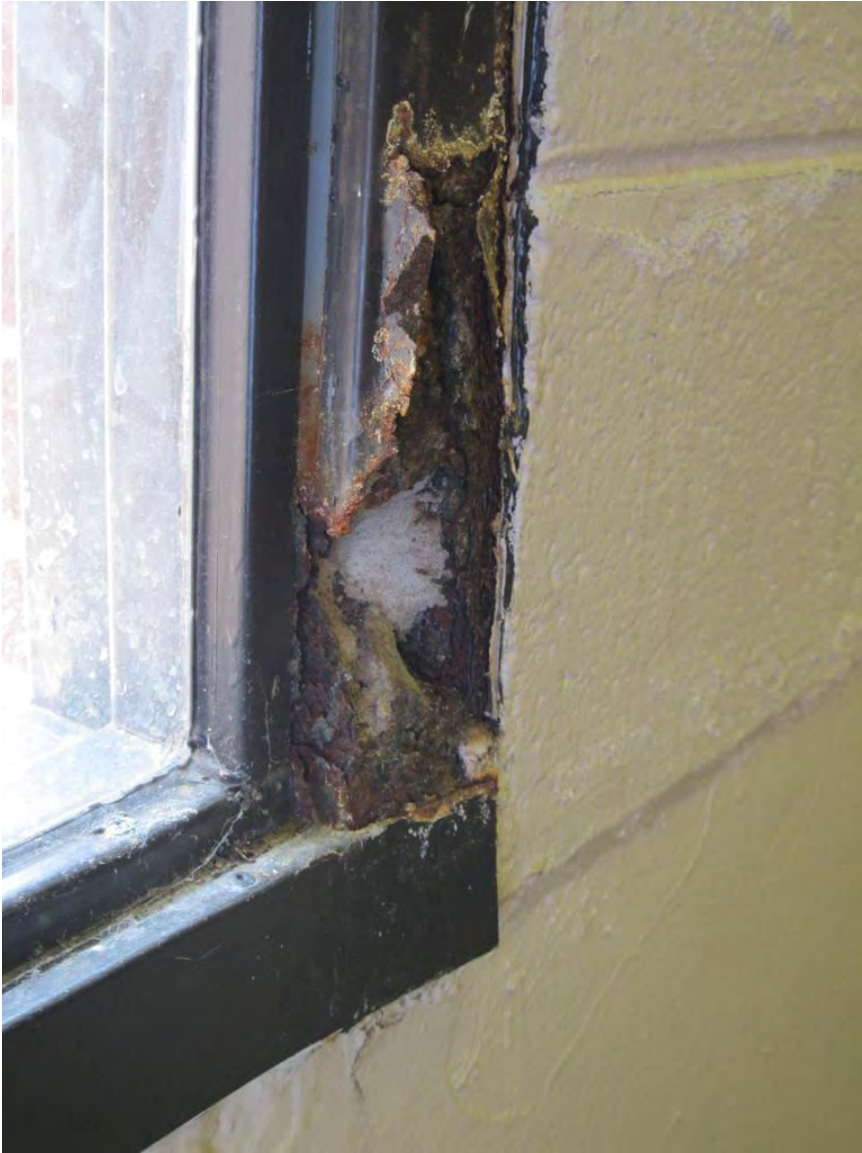
Deteriorated Window Frame

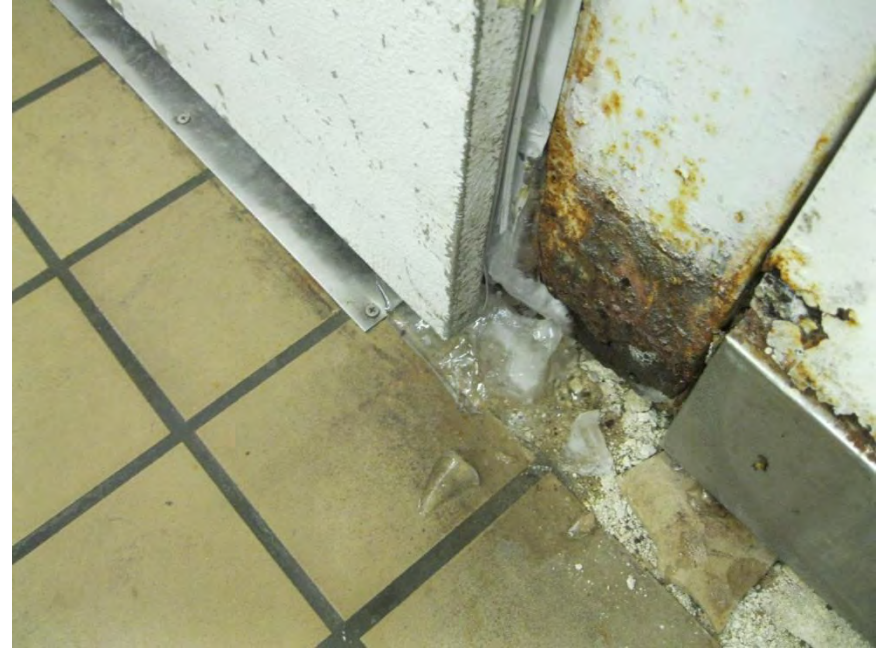
Deteriorated Freezer

2. Replace doors on building's south side near the auditorium; and
3. Replace cooler and freezer in the kitchen. (The District reports that this was completed following IFF's site visit.)

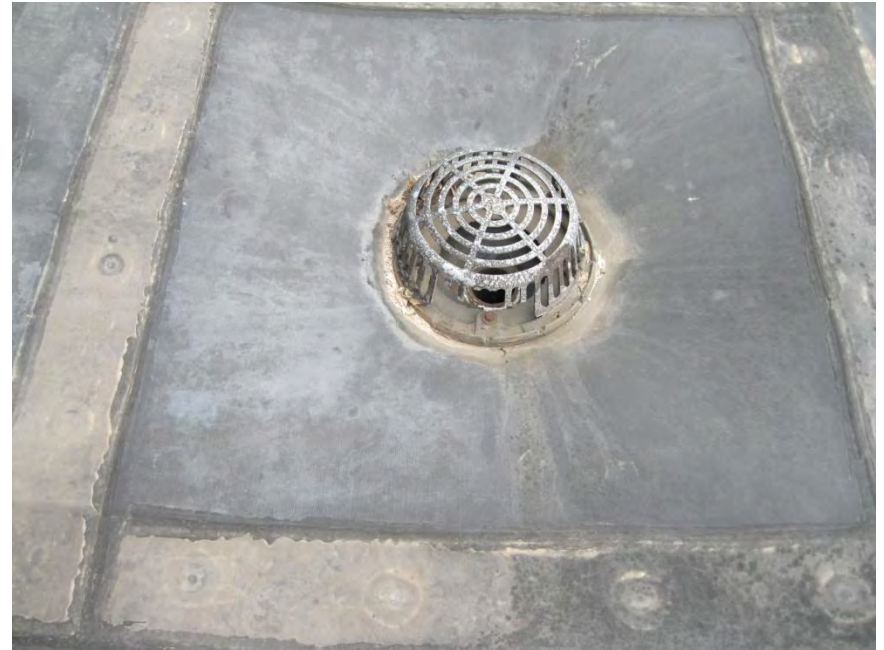
Roof Drain

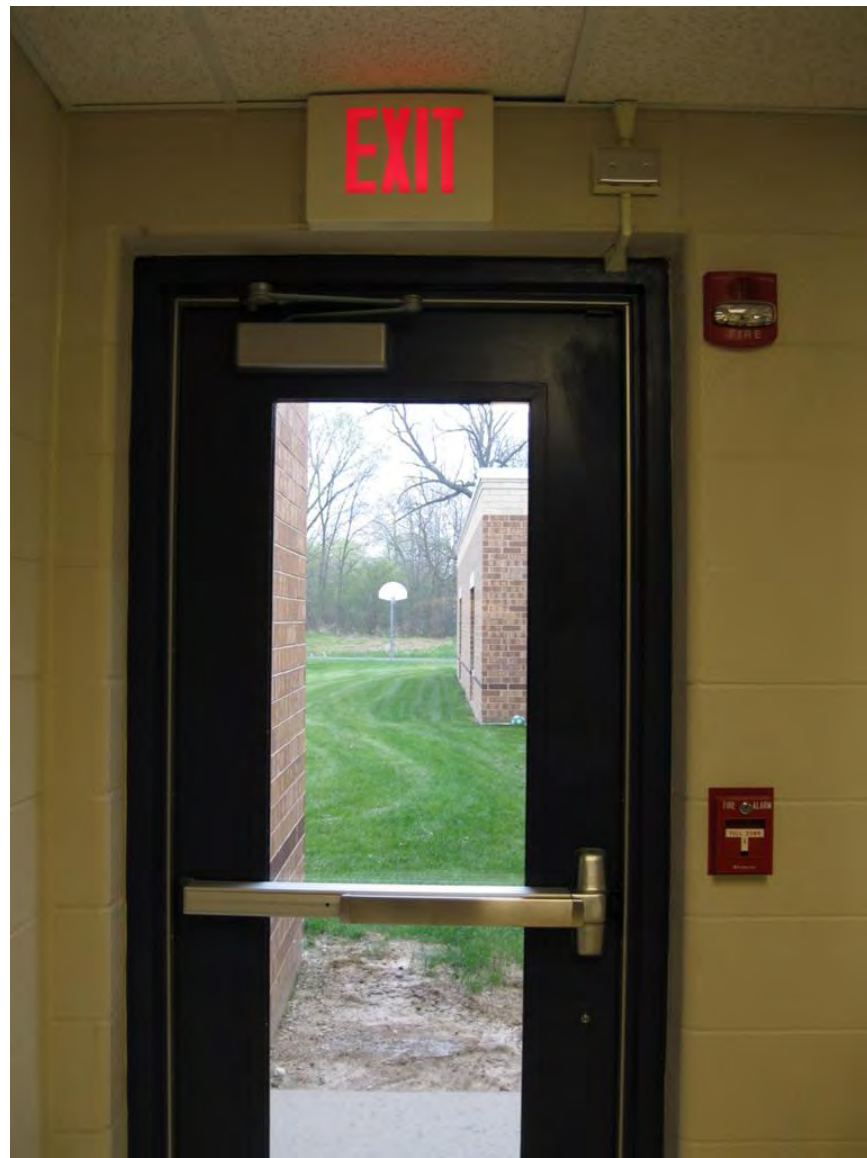
Typical Exterior Door

1. Paint - phased over time (\$75,000);
2. Treat exterior doors and frames with anti-corrosive coating (\$50,000), or alternately install FRP doors (\$400,000); and
3. Seal around all windows, curtain wall and exterior doors (\$45,000).

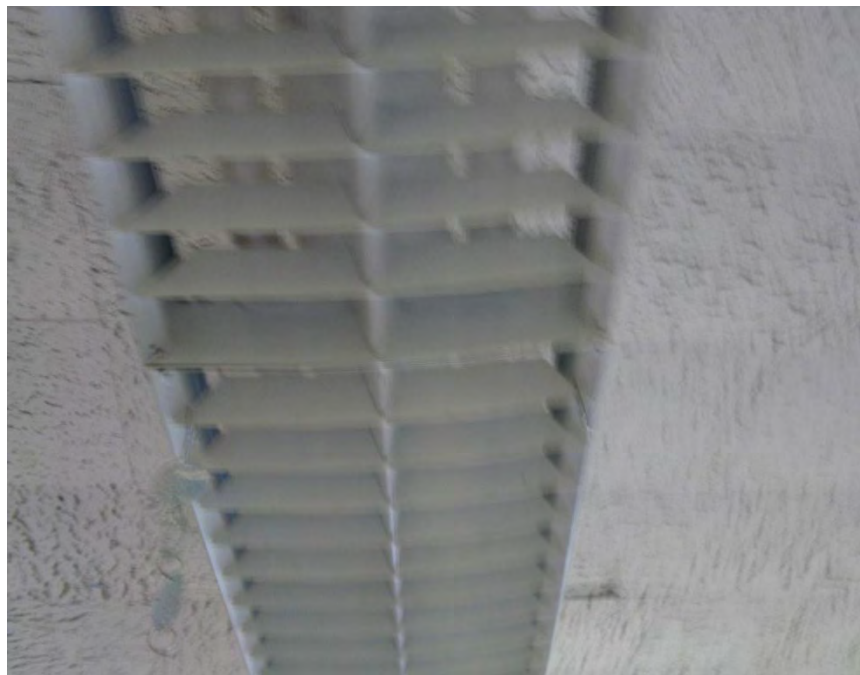
Typical Light Fixture

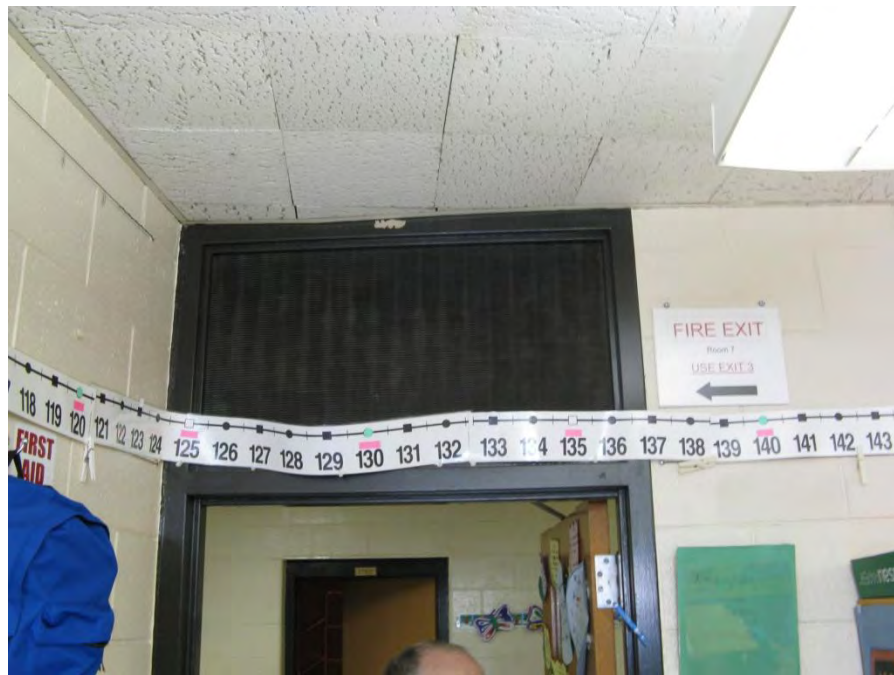
Door and Transom

1. Transoms above doors should be removed;
2. Replace doors into corridors, stairwells, and mechanical rooms that are not currently fire-rated and remove paint covering fire rating labels at existing rated doors;
3. Enclose stairways with proper fire-rated walls, install Code-compliant handrails, and provide designated areas of rescue assistance; and
4. Install complete, Code-compliant sprinkler systems as per the individual facility recommendations.

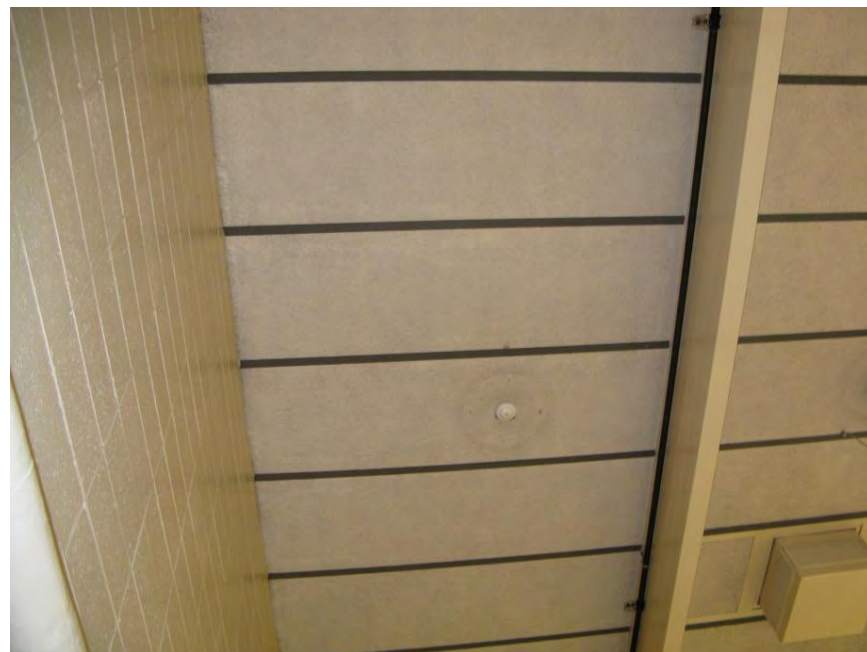
Gymnasium Ceiling with Typical Tectum Ceiling Panels

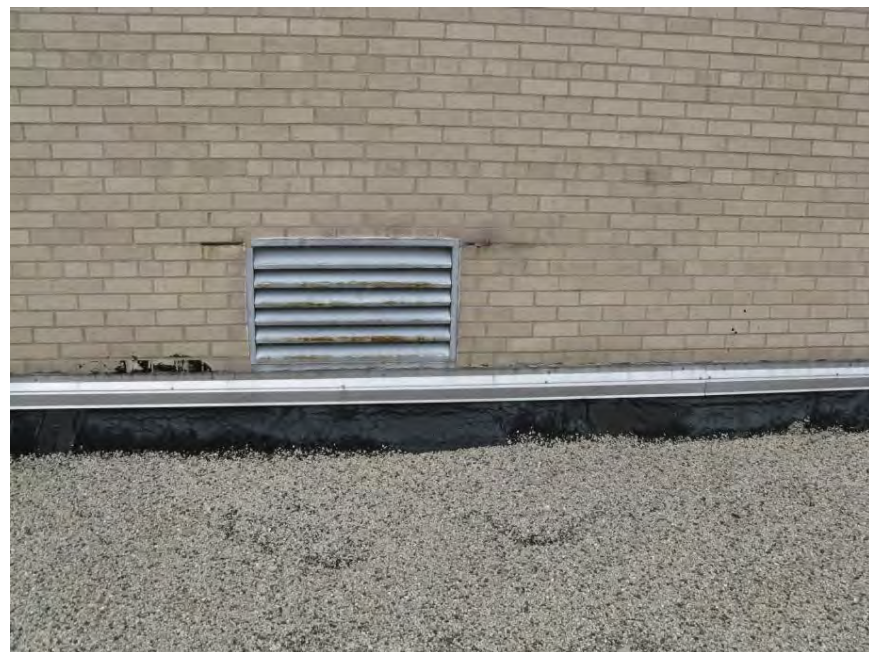
Ballasted Roof Showing Membrane Termination Detail and Vent

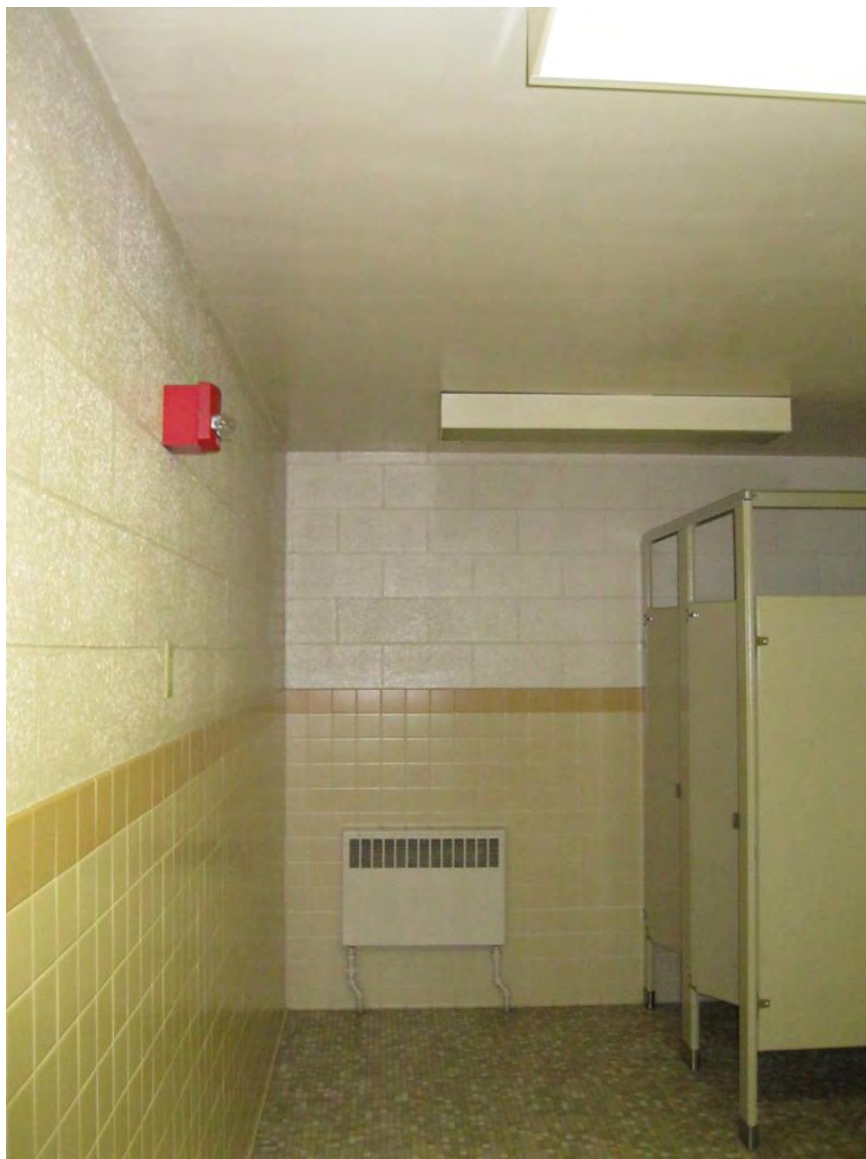
Typical Outdated Restroom
