School District of New Berlin  
Strategic Facilities Assessment  
Prepared by IFF  
August 2011

In the spring of 2011, the District engaged IFF to assist with this effort. During the month of May 2011, IFF visited each District facility and conducted an analysis of current building condition. Based on these assessments, IFF prepared a set of recommended short- and long-term facility improvements and completed a high-level cost estimate. Estimates represent a preliminary approximation of cost for discussion purposes. In setting priorities and recommending improvements, IFF assumed strategies that minimize costs and focus on ensuring that facilities are in compliance with current Code and life safety standards, address any deferred maintenance items, and bring facilities into standards for new construction. Standards for new construction, as used by IFF, indicates that the facility functions as it did when new and finishes are in as-new condition. Estimates do not include costs for improvements related to changing education standards or changes to meet a modern design aesthetic. IFF assumes strategies, where possible, that phase costs in over time and minimize annual outlays.

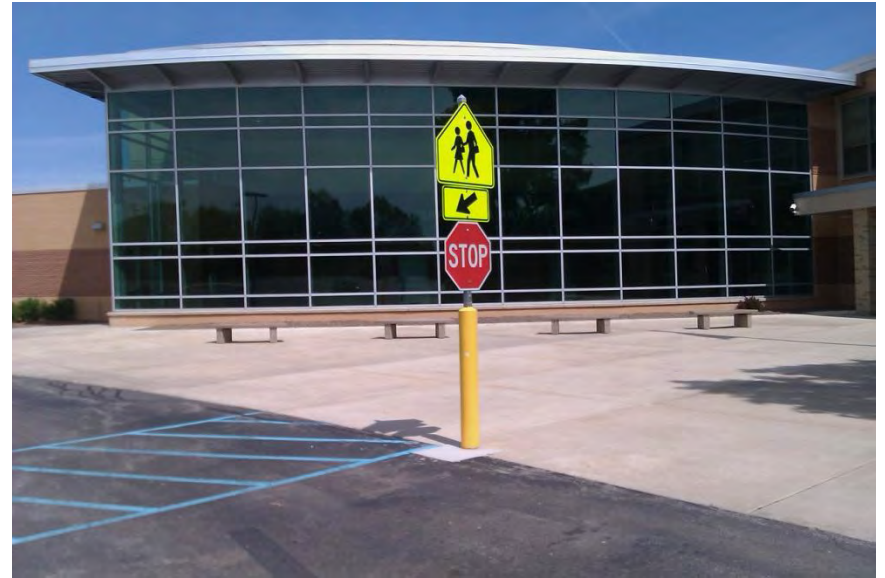
Performing Arts Center Glass Curtain Wall

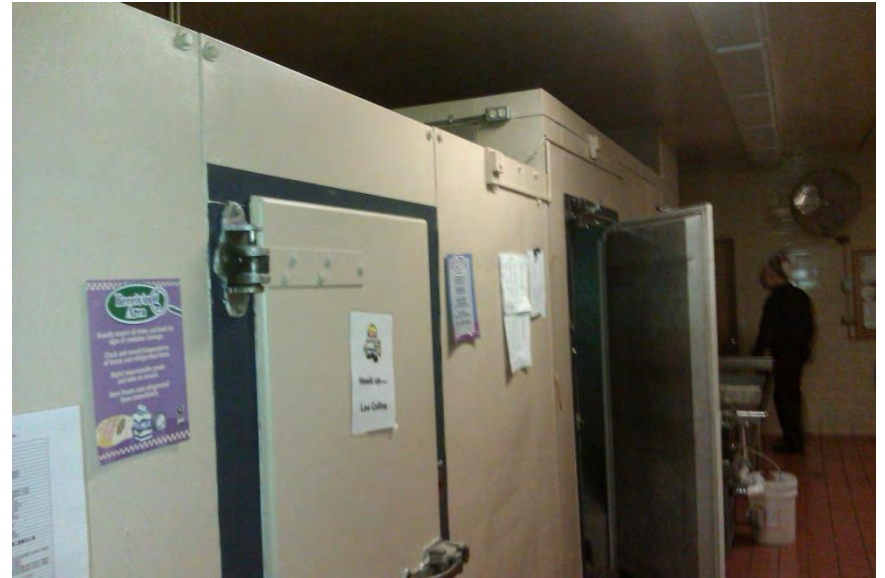
Kitchen Freezer & Cooler

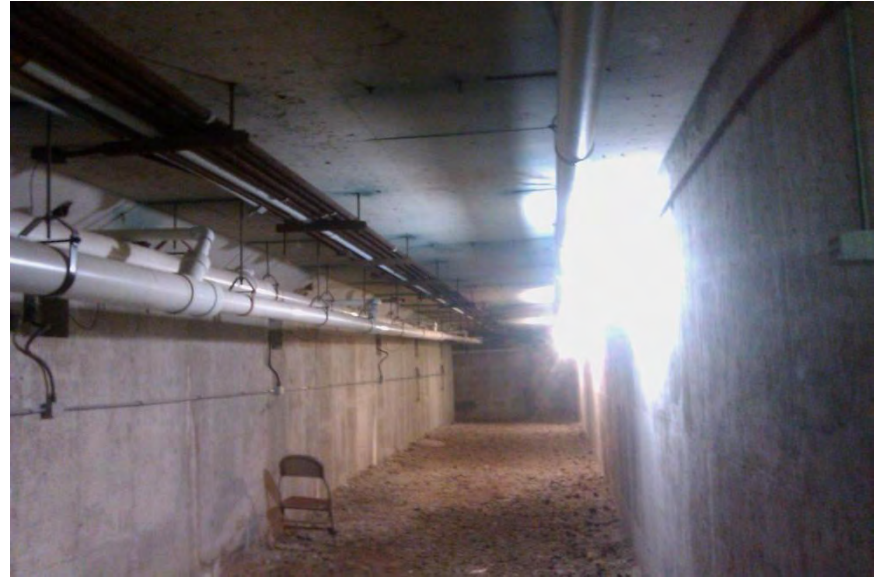
There are several mechanical equipment rooms throughout the facility, with differing areas of influence and a variety of climate control equipment in each room. The swimming pool is an original feature of the campus, having been in service since the early 1960's. New Berlin West's pool presents similar problems related to leaking and

Swimming Pool Below Ground Corridor

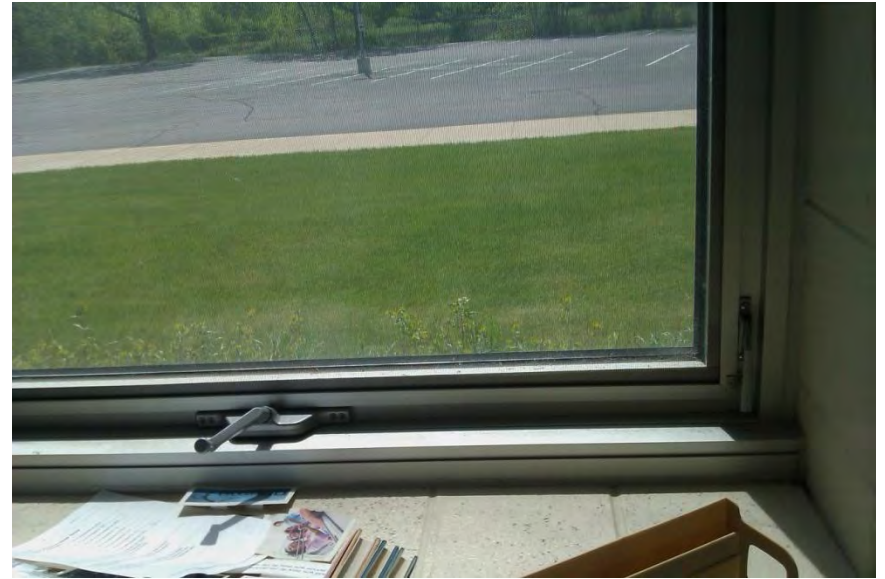
Typical Older Window

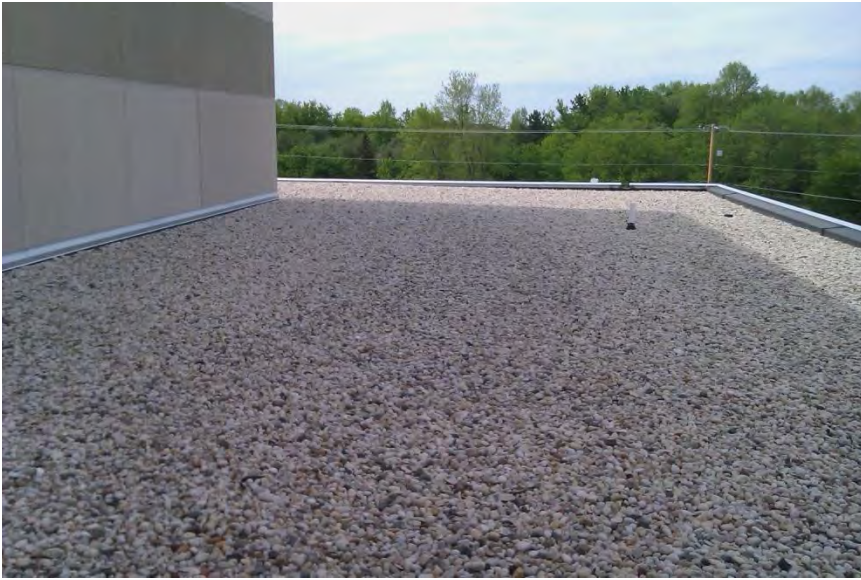
Ballasted EPDM Roof

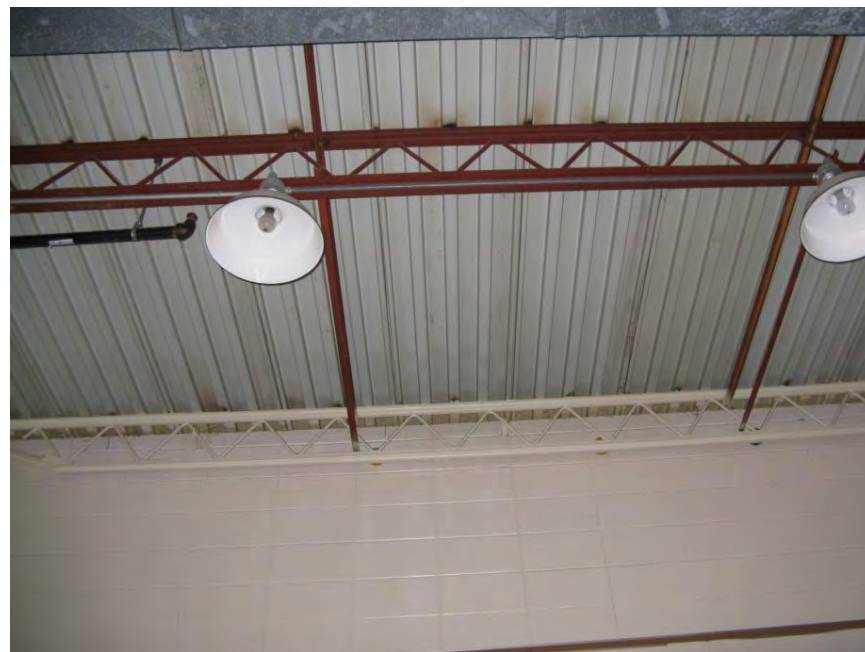
Assembly Hall Ceiling Showing Outdated Light Fixtures
