School District of New Berlin  
Strategic Facilities Assessment  
Prepared by IFF  
August 2011

In the spring of 2011, the District engaged IFF to assist with this effort. During the month of May 2011, IFF visited each District facility and conducted an analysis of current building condition. Based on these assessments, IFF prepared a set of recommended short- and long-term facility improvements and completed a high-level cost estimate. Estimates represent a preliminary approximation of cost for discussion purposes. In setting priorities and recommending improvements, IFF assumed strategies that minimize costs and focus on ensuring that facilities are in compliance with current Code and life safety standards, address any deferred maintenance items, and bring facilities into standards for new construction. Standards for new construction, as used by IFF, indicates that the facility functions as it did when new and finishes are in as-new condition. Estimates do not include costs for improvements related to changing education standards or changes to meet a modern design aesthetic. IFF assumes strategies, where possible, that phase costs in over time and minimize annual outlays.

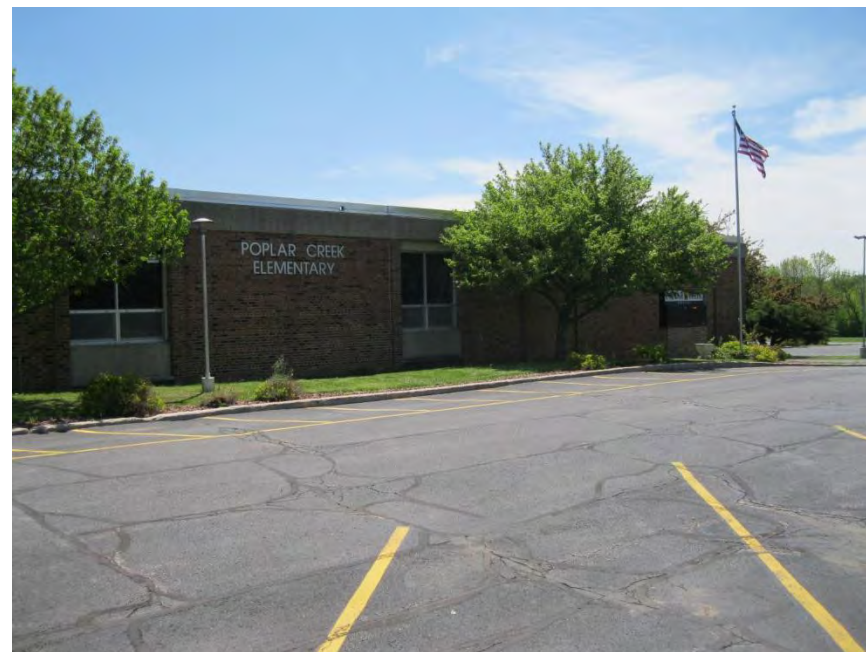
3. Exterior windows are operable single-pane, non-insulated glazing units with aluminum frames throughout. Replacement of all windows with thermally insulated, operable units is recommended, and the cost for this work is shown as being phased in over several years.

6. The age of the building indicates that the weatherproof seals at all window and door frames have likely deteriorated over time. IFF recommends that all exterior door frames and windows be caulked where they abut the exterior brick.

Front Building Facade

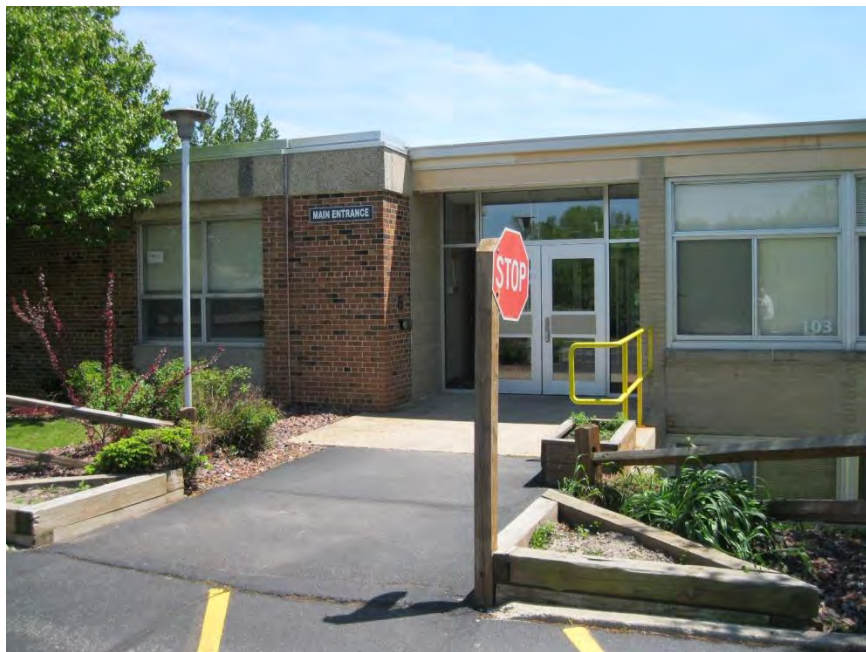
7. The existing entry doors exhibit very few signs of corrosion, in contrast to the level of corrosion experienced at other District facilities. IFF recommends at this time that the doors be treated with an appropriate rust inhibitor and monitored for signs of

Main Entrance

corrosion. For future replacement of the doors, the use of FRP doors is often recommended in schools and other public institutions because they are better able to resist wear and corrosion and are often considered easier to clean than typical hollow metal doors. The expected service life of the FRP doors can be up to three to four times that of a typical hollow metal door in a public school application. However, there is a significant premium associated with upgrading the doors, and the school District should balance its long term maintenance costs against its immediate budget constraints when choosing what product will best fit the long term needs of the facility and the staff.

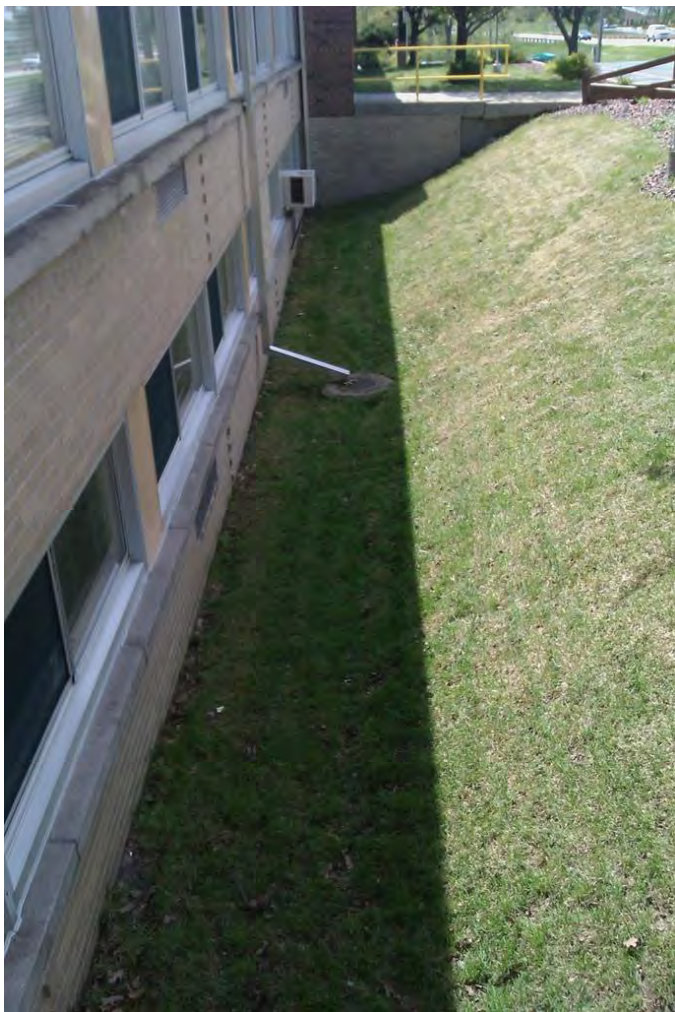
2. A substantial change in grade elevation occurs in the landscaped transitional space between the parking lot and the face of the building, allowing natural light to reach lower level windows on the north side of the building. Concrete walkways, at the same elevation as the parking lot and the entrance doors, permit access from the lot to the entrances, and steel handrails on either side prevent falls into the grassy pitched area of grade transition. IFF recommends replacing these rails to better prevent students from accessing the sloped area, while still allowing access for maintenance staff to manage the landscaping in the vicinity. Projected costs for this work are included in the long-term needs section of the attached cost estimate.

Landscaped Swale at Front of Facility

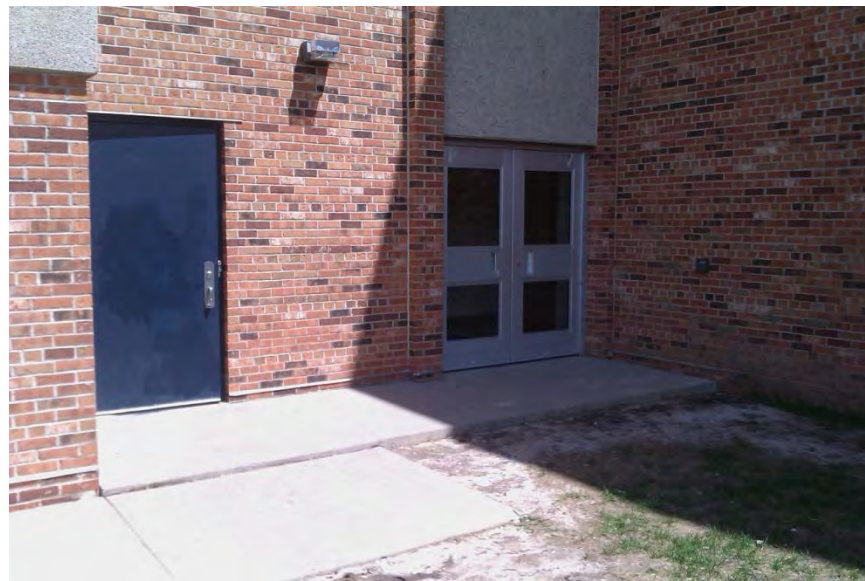
Rear Entryway Doors

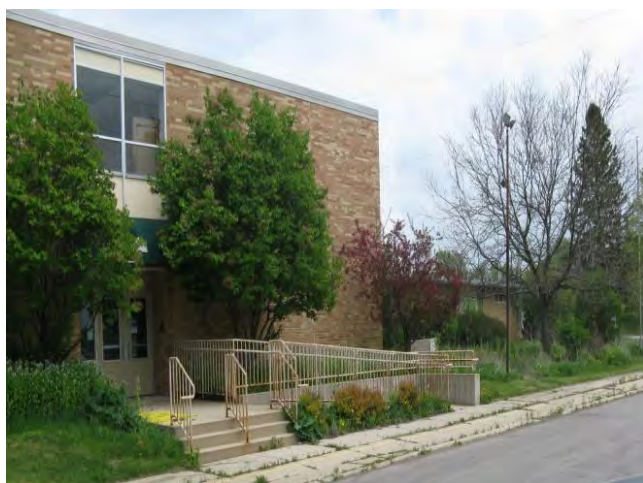
5330 South Racine Avenue  
New Berlin, Wisconsin

The former Prospect Hill School encompasses approximately 80,000 square feet on a seven-acre parcel located within the southwest quadrant of the geographic boundaries of the District. Constructed in the 1950s, the District has not used the facility for several years, and significant deterioration has taken place in that time frame. The facility is currently used by the New Berlin Police Department for training purposes.

The Prospect Hill School would require a thorough renovation of all aspects of the building if the District wishes to resume operating the facility. During IFF's visit in May 2011, no gas service or domestic water was available within the building, having been shut down by the District for safety and maintenance purposes. The District maintains the grounds surrounding the facility, but does not maintain the interior of the building.

IFF identified significant required upgrades required to operate the facility, but a comprehensive list of repair priorities will require a more thorough investigation by licensed architects and engineers. The major issues identified by IFF include substantial unresolved roof leaks at several locations, dysfunction of the well water and septic systems, unabated asbestos-containing materials throughout, and aging boilers which may not function properly when restarted. Most, if not all, of the existing door hardware would require replacement with accessible hardware. Much of the flooring throughout the building is damaged and will need to be replaced. The ceiling grid is removed or damaged by roof leaks in multiple locations. Many of the unit ventilators have been dismantled. There is no elevator to provide accessibility to the second floor.

Depending on the District's economic condition and the opportunities available to dispose of the site or construct an updated facility on the parcel, demolition of the existing structure may be the most effective means of managing the property. Several factors contribute to the overall demolition costs of this facility. An approximate cost for the demolition of two-story institutional building can be expected to range from approximately \$0.50 to \$1.20 per square foot, depending on the scope of work undertaken, excluding remediation of environmental concerns. Other factors such as the configuration of footings and foundations, requirements from utility service providers, and requirements for the condition of the parcel after demolition have a substantial impact on demolition costs. Observations made during IFF's walk-through strongly suggested the presence of lead paint and asbestos, particularly in the boiler room and in outdated hallway floor tiles. Subject to actual quantities and locations of asbestos or other environmental factors, an additional expenditure of \$0.50 to \$1.00 per square foot for remediation may be necessary.

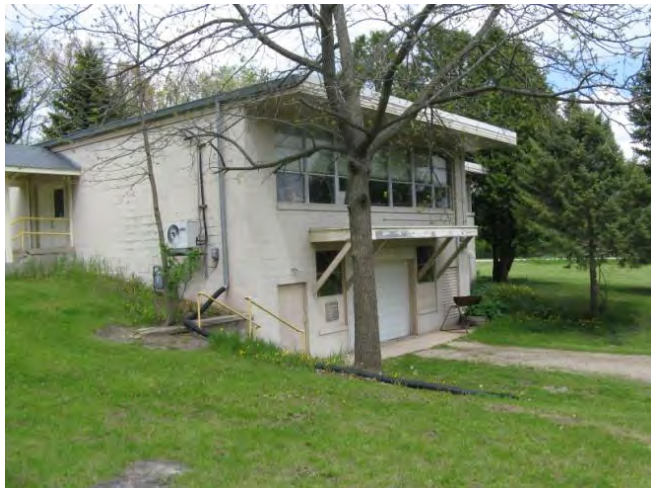
3800 South Racine Avenue  
New Berlin, Wisconsin

The Little Grove facility is a small structure, approximately 5,600 square feet, located on a 10-acre site in a mostly undeveloped section of New Berlin. Constructed in approximately the 1950's, the building is used by the District's facilities staff for maintenance purposes. The site is undeveloped, except for the structure and the associated well and septic system. A small dirt and rock covered road provides access onto the site and up to the building.

The building and the site remain in functional condition. No immediate hazards to occupant safety were identified, and no problems limiting the current use of the facility were reported. However, the age and use of the building indicate that the need to implement repairs is approaching. District staff report that the building is still in frequent use as storage of potentially useful parts, when needed for repair of items such as furniture and equipment. None of the buildings and ground staff use this facility as a permanent office, and most of the activities performed at Little Grove can be performed within the maintenance areas of the middle/high schools.

IFF recommends the District take incremental steps to ensure that the facility continues to function safely and adequately to meet the needs of its maintenance staff. The District should continue to monitor and repair the roof when needed, verify that the climate control systems function adequately, upgrade the locks to prevent break-ins, and eliminate any infiltration immediately upon discovery. Costs for renovating this facility depend largely on the District's goals for the facility and may range anywhere from a few dollars to thousands of dollars per square foot. Disposition of the facility may be the best long-term solution.
